# **Intel® Mobile Pentium® III Processor Specification Update**

Release Date: June 2000

Order Number: 245306-008

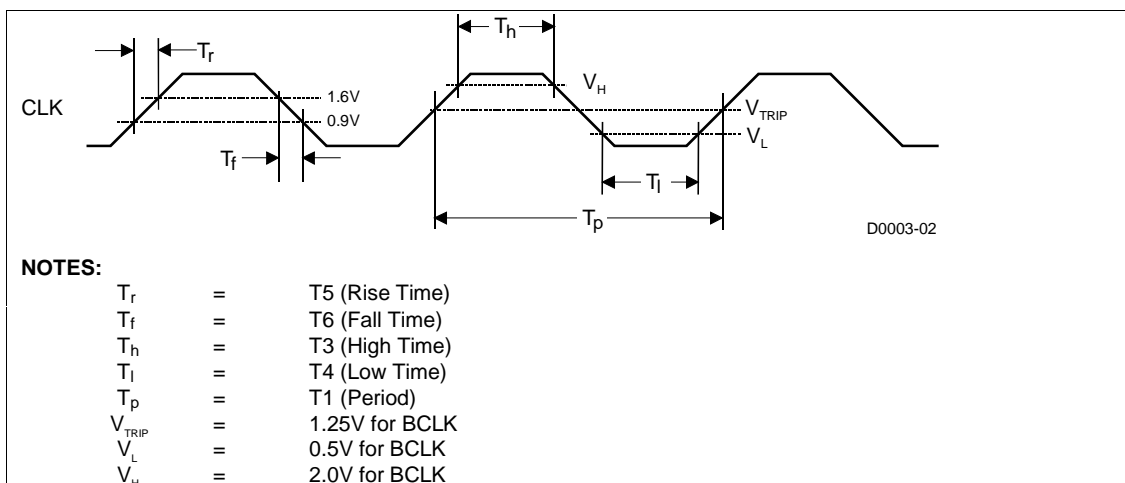
Figure 7. BCLK Timing Waveform

Symbol	Parameter	Min	Typ	Max	Unit	Figure	Notes
	System Bus Frequency		100		MHz		
T1	BCLK Period		10		ns	Figure 7	Note 2
T2	BCLK Period Stability			$\pm 250$	ps		Notes 3, 4
T3	BCLK High Time	2.70			ns	Figure 7	at >2.0V
T4	BCLK Low Time	2.45			ns	Figure 7	at <0.5V
T5	BCLK Rise Time	0.175		0.875	ns	Figure 7	(0.9V – 1.6V)
T6	BCLK Fall Time	0.175		0.875	ns	Figure 7	(1.6V – 0.9V)

1. All AC timings for GTL+ and CMOS signals are referenced to the BCLK rising edge at 1.25V. All CMOS signals are referenced at 0.75V.
2. The BCLK period allows a +0.5 ns tolerance for clock driver variation.
3. Not 100% tested. Specified by design/characterization.
4. Measured on the rising edge of adjacent BCLKs at 1.25V. The jitter present must be accounted for as a component of BCLK skew between devices.

For B0 step processors, the  $V_{IH,BCLK}$  Min spec is changed to 2.0V (from 1.7V for A2 step) and  $V_{IL,BCLK}$  Max spec is changed to 0.5V (from 0.7V for A2 step). Due to this, new values are specified for BCLK high and low times for B0 step processors. These modifications affect corresponding specs in Table 13, Table 14, Table 24, and Figure 7 in *Mobile Pentium® III Processor in BGA2 and Micro-PGA2 Packages datasheet* (Order Number 245302-002).

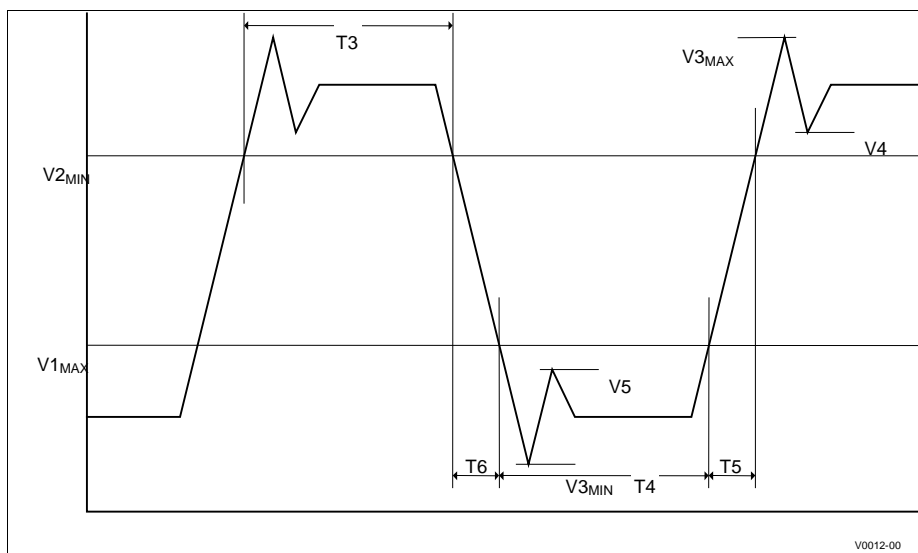
Figure 4. BCLK Waveform at the Processor Core Pins

In Table 18, “BCLK Signal Quality AC Specifications at the Processor Core” of the *Intel® Pentium® III Processor Mobile Module: Mobile Module Connector 2 (MMC-2)* datasheet, and Table 19 of the *Intel® Pentium® III Processor Mobile Module: Mobile Module Connector 2 (MMC-2) Featuring Intel® SpeedStep™ Technology* datasheet, Note 3 has been updated. Figure 4 “BCLK Waveform at the Processor Core Pins” has also been updated. See below.
